# Product Safety Recall

## YAMAHA TMAX Motorcycle Main Stand Breakage

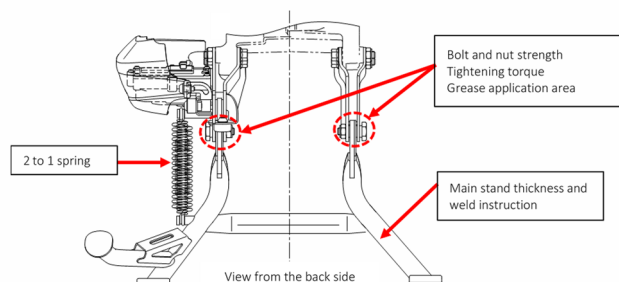
The strength of the XP530A main stand may be compromised due to substandard welding at the cross tube.

Repeated operations of the main stand may cause cracking at the weld areas and possible breakage. If the stand was to break and the bike was to fall over, it could cause serious injury to the rider or bystanders.

To correct this defect, Yamaha is initiating a Factory Modification Campaign, whereby affected XP530A models must have the main stand replaced with one that has been strengthened by increasing the tube thickness and modifying the welding process.
